The U.S. Marine Corps invited the media Aug. 28 to visit the USS Wasp amphibious assault ship where the second set of developmental test trails for the F-35B are taking place. Being the savvy PAs that they are, USMC shipped us out and back on their newest rotorcraft, the Bell/Boeing MV-22 to see their newest fighter. (They also happen to be the Pentagon's most expensive rotorcraft and fighter).

DT-2 is a follow on Aug. 12-30 to expand the envelope for the aircraft operating around the ship to include night operations, and landings using various headings on the aft parking area of the USS Wasp.

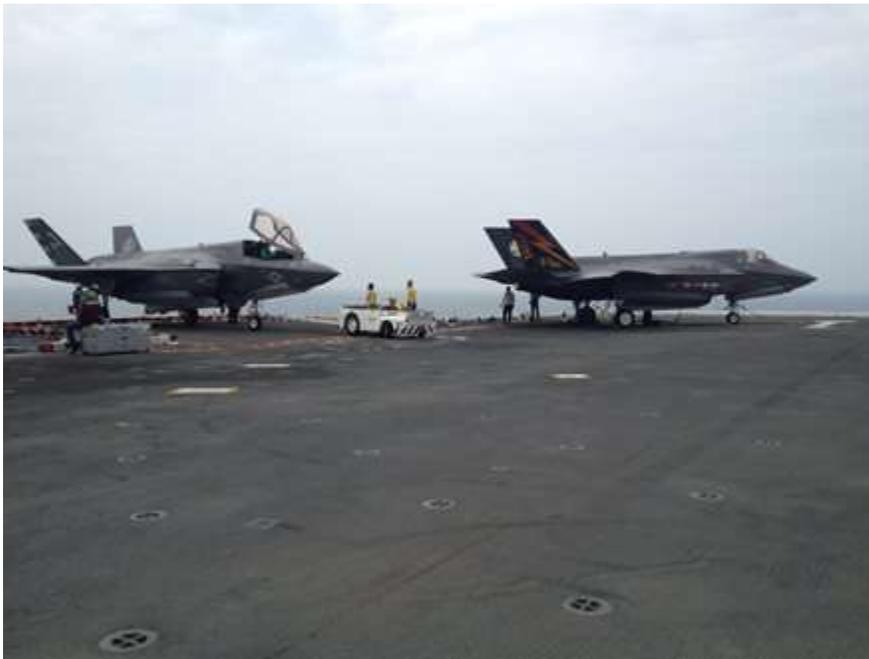
Officials reported a 90% availability rate of the two aircraft during the trials as of Aug. 28, but unfortunately both BF-5 (left) and BF-1 (right) were both down in the morning when we were on the ship owing to maintenance issues.

BF-1, heavily instrumented for the trials, was down owing to a faulty cooling fan in the engine nacelle; this was repaired and the aircraft conducted flights later in the day after we departed the ship. BF-5, a production representative model, was having trouble with its thermal management subsystem.

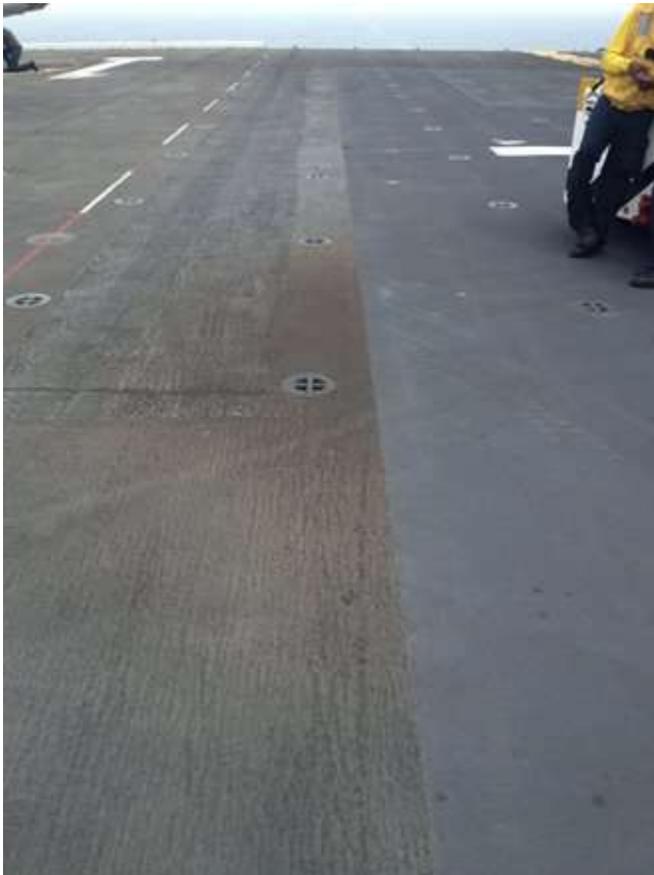
Below, the dark section on the right is the Thermion coating. You can see on the left where Wilson landed with the engine nozzle just over the divider between the Thermion and standard anti-skid -- the the latter a bit toasted.

During one of the tests, Wilson landed an F-35B with its nose off toward the port side of the deck and its engine and hot nozzle exhaust on the port side. During this test, the engine nozzle was just at the

demarcation on the deck between the Thermion and baseline anti-skid coatings on the deck. The effects are obvious. The anti-skid coating is brown as a result of the intense heat, while the Thermion appears unaffected.

Spitz says that while the anti-skid coating typical on can handle F-35 operations, its service life could be compromised over time. So, the Navy is assessing whether it will outline decks – or at least portions to be used by the F-35B – with this Thermion material in the future. The performance tradeoff is cost; Thermion is more expensive, he says.
